Passive Treatment of Toe Drain Discharges from a Tailings Storage Facility using an Oxidic Granite Bed

Robert S Hedin¹, Jeffery Millgate², Brian Authurs², Ron Nunn Patrick², Vinath Khamsana² and Neil Wolfe¹

¹Hedin Environmental, USA; ²Phu Bia Mining Company, Lao Peoples Democratic Republic

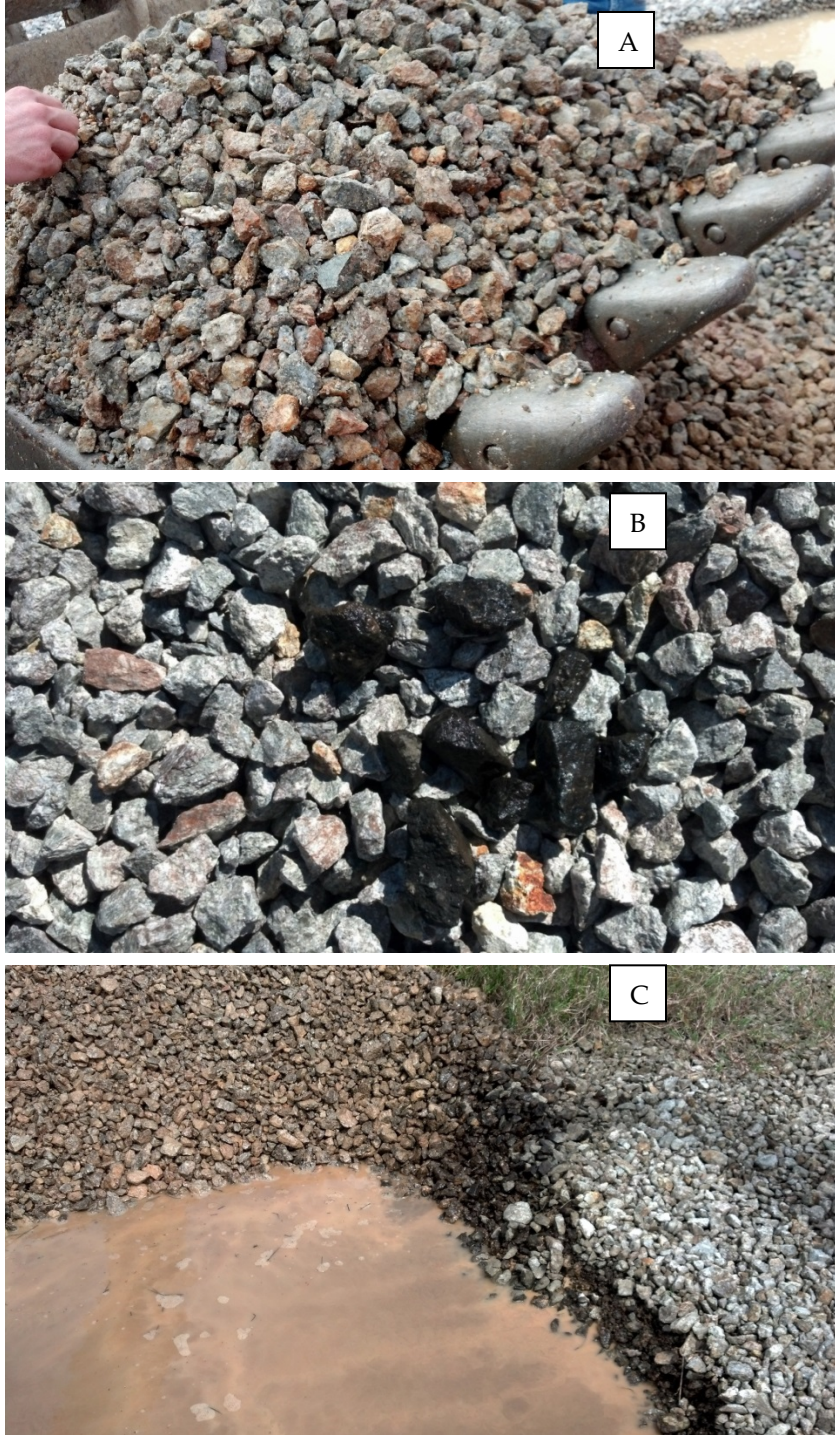
In mid-2014 water was observed flowing on top of a portion of the aggregate bed. In October 2014 an excavator was mobilised to investigate the change in hydraulics and also to investigate the condition of the aggregate. Flow on the top of the aggregate was limited to the first 25% of the bed. The investigation found algal growth on top of the stone that had created a dense biofilm that promoted flow of water on top of it. When the algal growth was disrupted by mixing the stone, water flowed into the aggregate and no longer flowed on the surface. The cause of the algal growth was suspected to be due to settling of the stone in the first portion of the bed, which allowed water on the surface during high flow conditions. During these conditions, algae growth was enabled. As a result of this observation, the effluent of the bed was lowered by 50 cm so that water would never flow on the surface and growth of algae would be inhibited.

The aggregate in the bed was inspected for signs of Mn removal. The raw granite is grey. Mn oxides form a black coating on the rocks. The aggregate in the final 25% of the bed did not have any black coloring, indicating that little Mn removal is occurring in this section (Figure 4a). As the investigation moved forward into the bed, stones stained black became visible (Figure 4b). In the first quarter of the bed, most of the stone in the top 30 cm was black (Figure 4c). The Mn staining was limited to the top 50 cm of the bed. Beneath 50 cm the aggregate retained its original grey color. These observations indicate that little Mn removal is occurring in the bottom 1.5 m of aggregate. When combined with the observations from the end of the bed, it was apparent that only 15% of the aggregate was involved in Mn removal. This condition likely has two explanations. First, removal of Mn is so effective in the first half of the bed that there is little Mn left for removal in the second half of the bed. This explanation suggests there is a large excess capacity for Mn removal in the second half of the bed which will be useful should Mn loadings increase. The observation that there is little visible Mn removal occurring below 50 cm suggests that flow is not well distributed through the bed. As the influent and effluent structures are both at the surface, there is an apparent preference of flow in the top 50 cm of the bed. This condition could be partially corrected by reconstructing the effluent as a perforated pipe placed on the bottom of the bed. There are no plans to make this change at this time.

Figure 4 Aggregate encountered during system investigation. A) clean granite aggregate at the end of the system. B) black Mn-coated granite placed on clean stone to show contrast; C) layer of Mn-coated stone found in the first half of the bed.
